CONNECTICUT RIVER BASIN
SPRINGFIELD, MASSACHUSETTS

FOREST PARK UPPER DAM
MA 00568

PHASE I INSPECTION REPORT
NATIONAL DAM INSPECTION PROGRAM

SEPTEMBER 1979

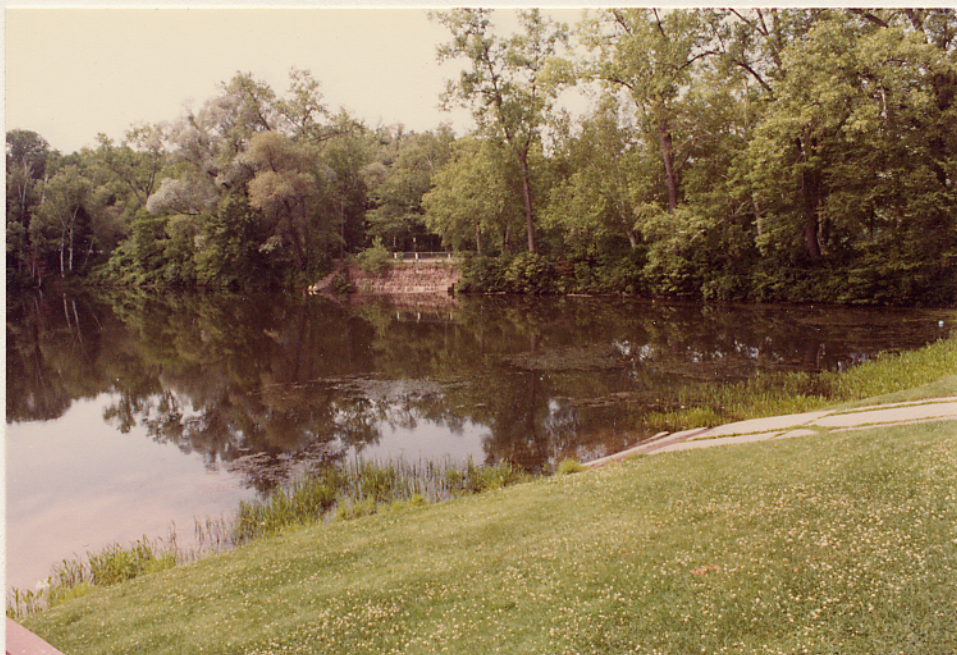
1. OVERVIEW OF UPSTREAM FACE OF DAM FROM RIGHT BANK OF POND.

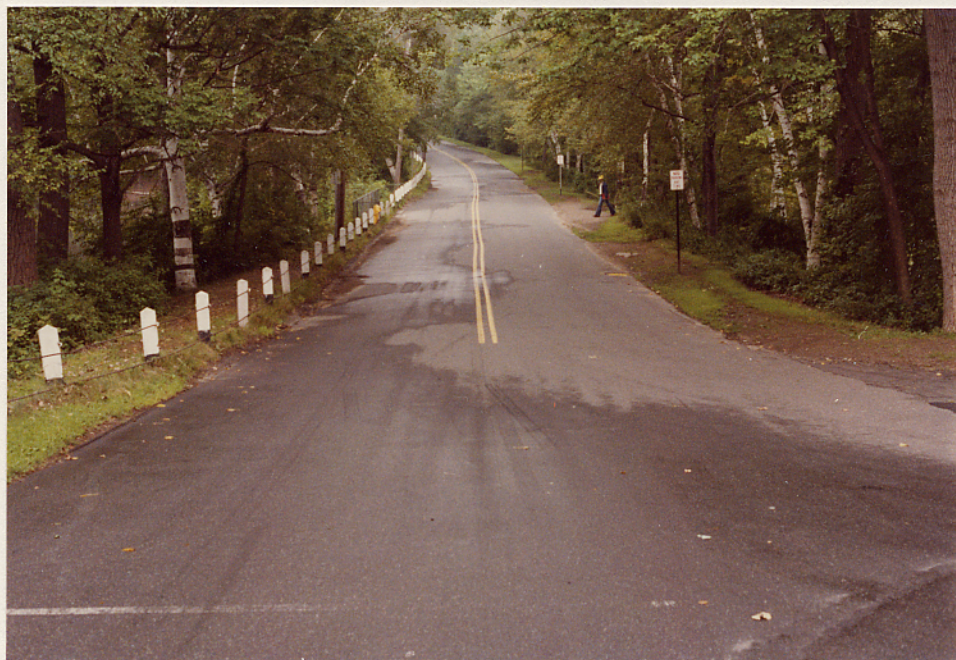
2. CREST OF DAM FROM RIGHT ABUTMENT.

- b. Dam - Visual observations indicate the dam embankment and spillway are in fair condition. The embankment crest has an asphalt paved roadway, about 26 feet wide as shown in Photo 2. In general, the pavement was judged to be in good condition. Some minor pavement cracking was noted. The remainder of the crest, along the pavement edges is grass and weed covered, with several worn paths and eroded patches. Curbing has been installed on the upstream side over a limited section at the center of the dam. Embankment materials exposed in the roadway area consists of approximately 12 to 18 inches of black cinders overlying light brown silty fine sand.

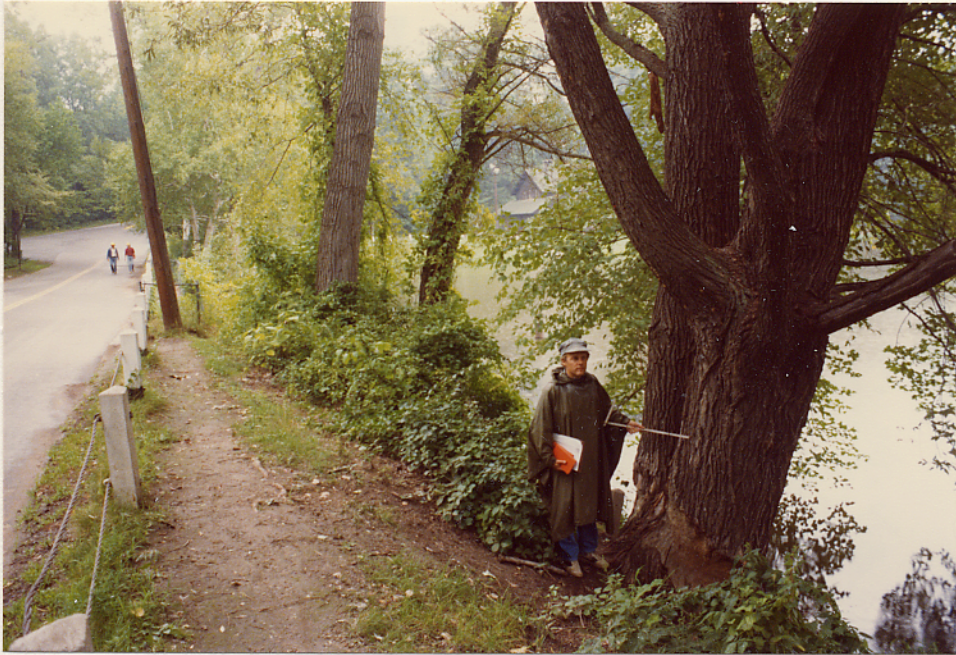
3. UPSTREAM FACE OF DAM FROM LEFT ABUTMENT.

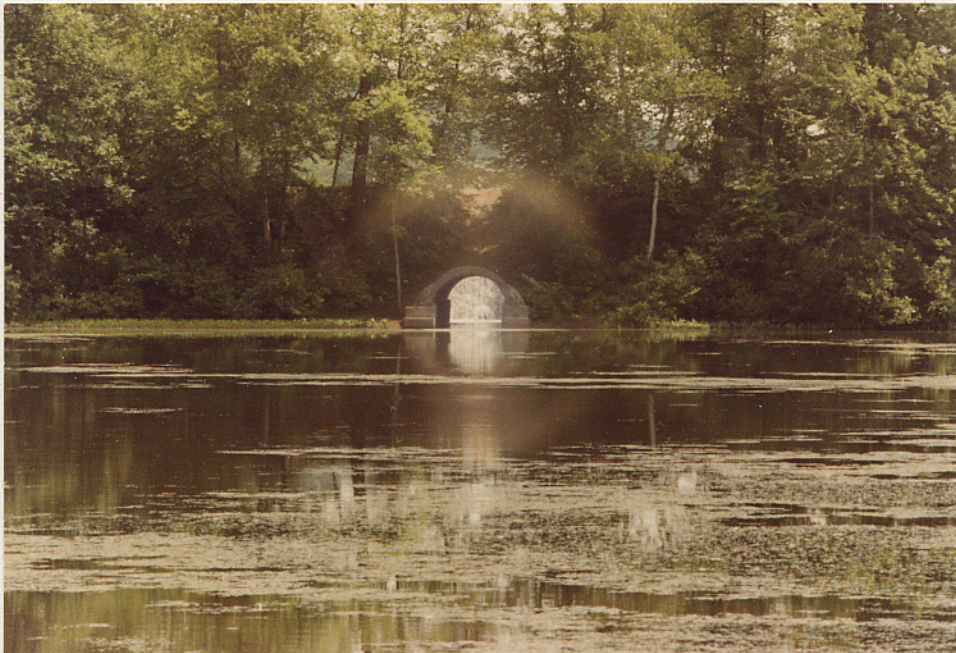
The upstream slope was estimated to be somewhat steeper than 2 H to 1V at several places. There is apparently no riprap or other wave protection. The downstream face of the dam appeared to be on a 2H to 1V slope. Eroded areas in this face, some up to 2.5 feet in depth, exposed a light brown silty fine sand material. One eroded area has apparently been stabilized with bricks. No evidence of seepage was noted along the downstream toe of the embankment.

4. DOWNSTREAM FACE OF DAM. NOTE EROSION ABOVE OUTLET CULVERT.

- a. Operation and Maintenance Procedures - The following remedial work should be undertaken by the owner:
 - (1) Make temporary repairs to eroded areas on the dam.
 - (2) Clear and repair catch basins and drains.

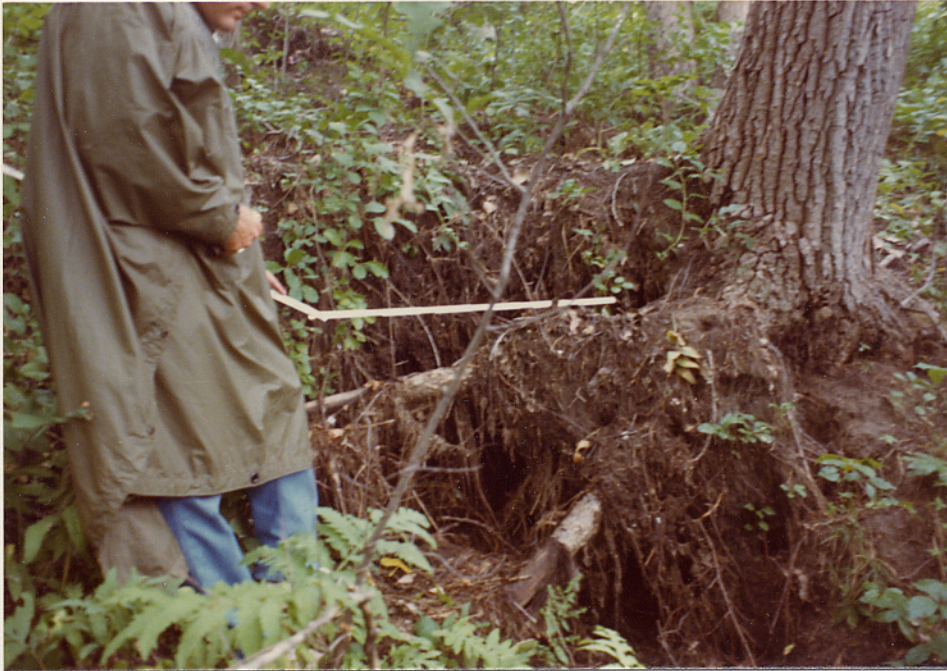
5. PARTIALLY UPROOTED TREE ON DOWNSTREAM FACE OF DAM.

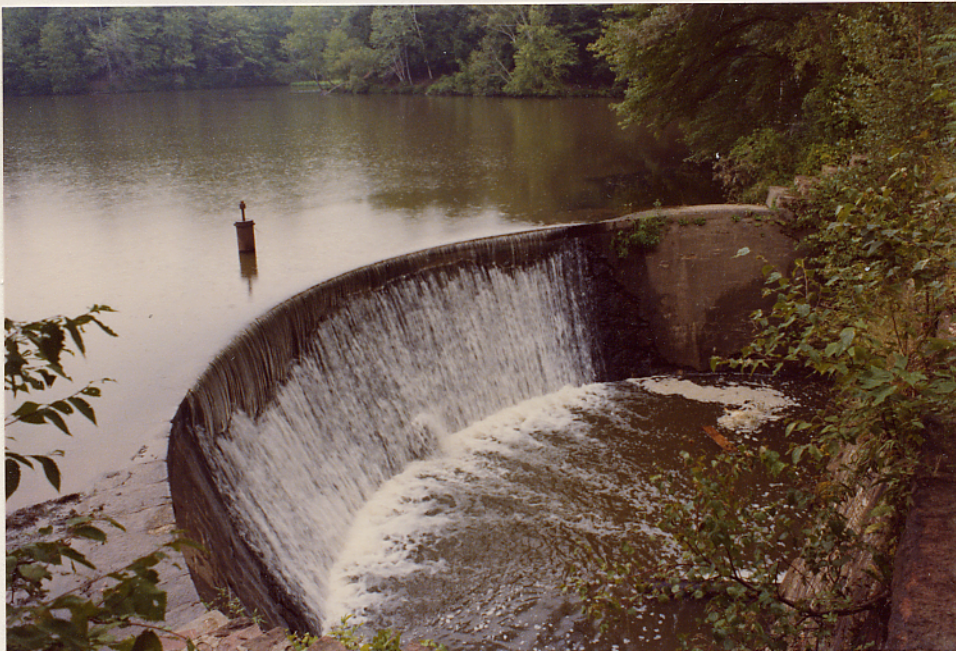
- (5) The mortar cap on the spillway weir is cracked and eroded as shown by the flow pattern in Photo 6.
 - (6) A slight growth of vines and grass at the right and left end of the spillway weir was observed. Slight seepage is present through the masonry joints at the right of the spillway weir.

6. OVERVIEW OF SPILLWAY AT UPSTREAM FACE OF DAM.

- (3) Remove vegetation from the stone masonry spillway and embankment walls.
- (4) Renew the cement mortar cap at the top of the spillway weir.
- (5) Replace the missing stones at the base of the vertical stone masonry wall at the front face of the dam embankment in the spillway area.
- (6) Repair the mortar plaster on the underside of the discharge culvert roof.
- (7) Establish a formal operational procedure and maintenance program.
- (8) Develop a formal emergency procedures plan and warning system in cooperation with local officials and institute a program of annual technical inspections.

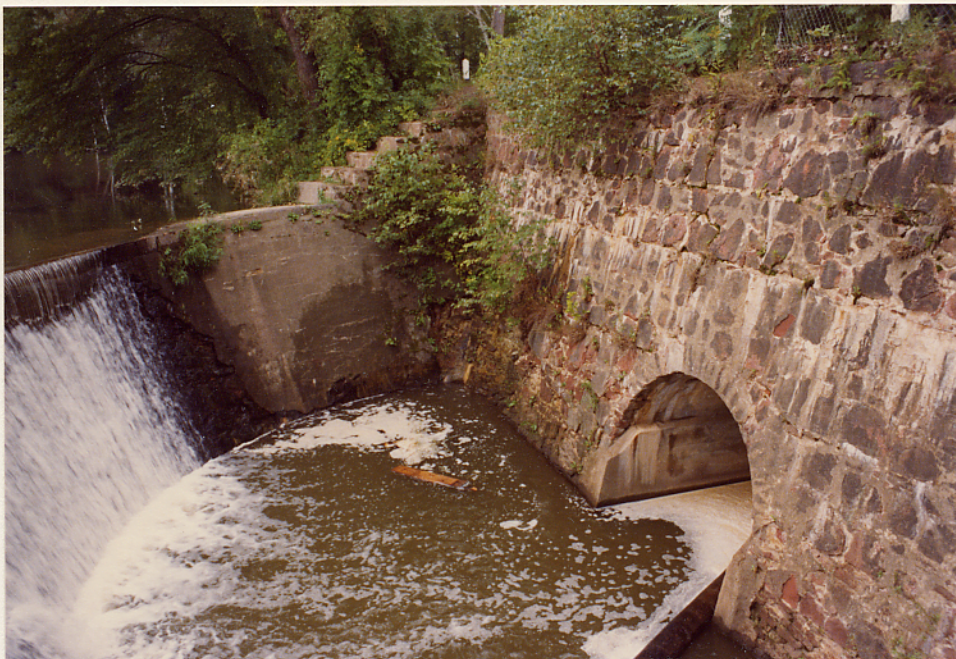
- (3) The catch basin on the downstream side of the roadway near the left abutment appears to be clogged.
 - (4) Vegetation is present in the masonry joints of the stone masonry wall at the upstream face of the dam in the spillway area. Stones are missing from the wall at the left and right end near the base of the wall. The condition at the left end of the wall is shown in Photo 7.

7. MASONRY WALL AT UPSTREAM FACE OF DAM AT SPILLWAY AREA AND ENTRANCE TO OUTLET CULVERT.

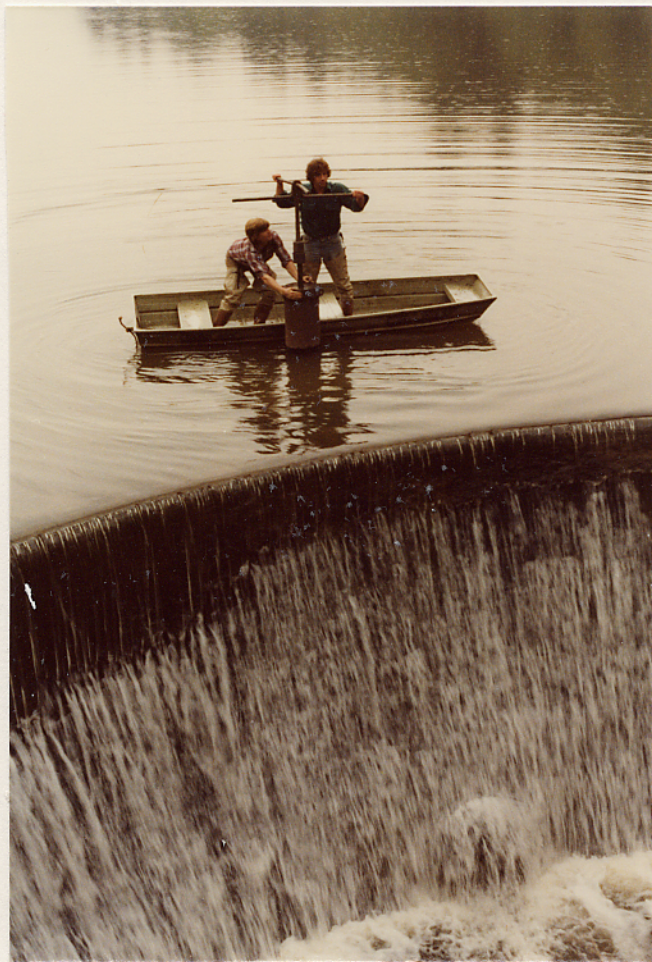
- (7) The mortar plaster on the underside of the culvert roof is cracked and pieces have fallen off.
- c. Appurtenant Structures - The reservoir drain is controlled by a gate operator on the upstream side of the spillway. The gate is operational. Access to the gate during normal or high flows is by boat as shown in Photos 8 and 9.

8. RESERVOIR DRAIN OPERATOR UPSTREAM OF SPILLWAY. NOTE DRAIN OUTLET AT BOTTOM RIGHT OF PHOTO.

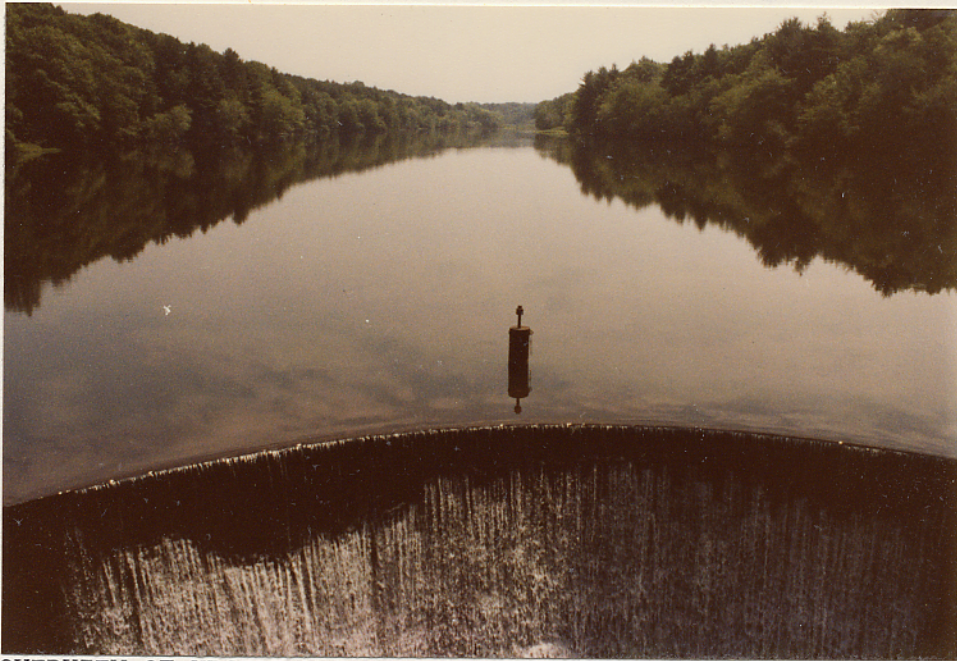
- d. Reservoir Area - Forest Park Upper Dam forms an impoundment called Porter Lake in Forest Park. There is no development in the vicinity of the reservoir area as shown in Photo 9, except for park facilities. There is a park concession building at the right bank just upstream of the dam. Side slopes to Porter Lake are generally flat to moderate. There appears to be no potential for landslides into the reservoir which would cause waves to overtop the dam. No conditions were noted which might result in a sudden increase in sediment load into the reservoir.

9. OVERVIEW OF UPSTREAM POND WITH PORTION OF SPILLWAY CREST AND RESERVOIR DRAIN OPERATOR IN FOREGROUND.

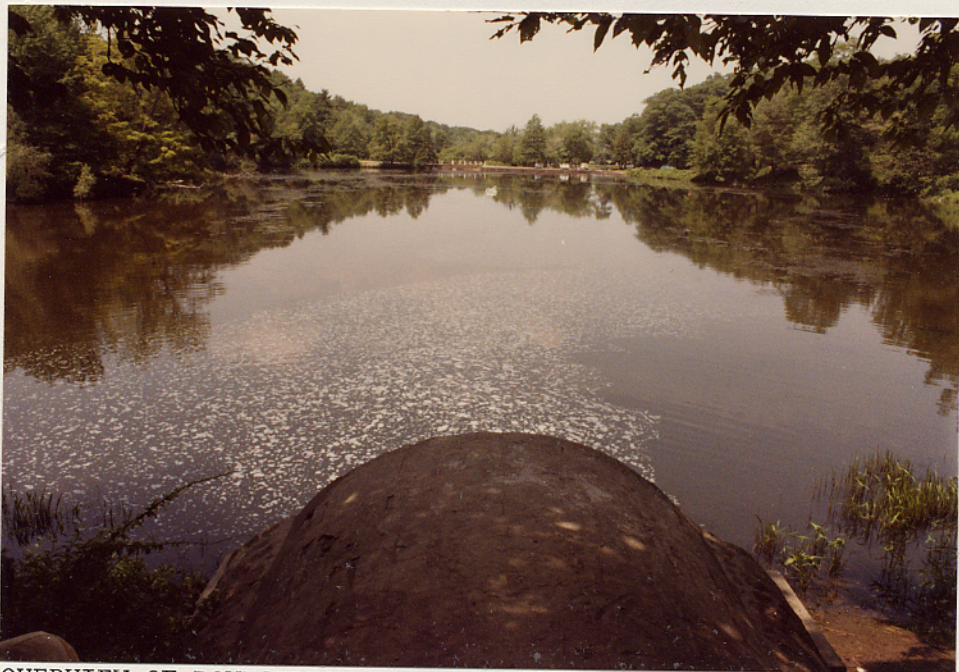
10. OVERVIEW OF DOWNSTREAM POND WITH DISCHARGE END OF OUTLET CULVERT IN FOREGROUND.
